Happy Valley outfall channel

Community Working Group
Meeting 3 (22 October 2013)

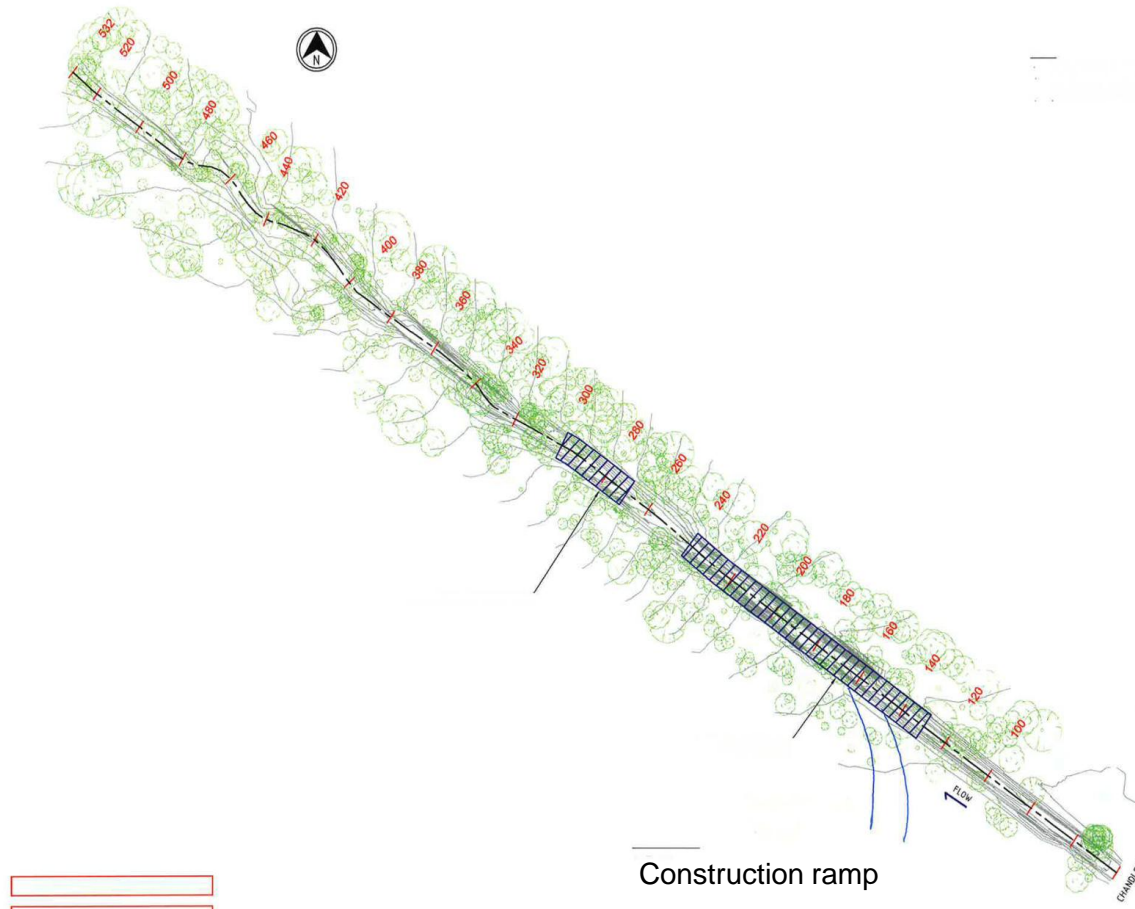
Option C: Work from within channel (with access)

- **Work from within channel (with access)**

- Create access ramp into the culvert

- Work into channel to clear channel, remove top of banks and clear culverts

- Re-establish bank integrity through re-grading where necessary

- Some tree loss necessary but able to be controlled

- Safe access in and out of channel

- Limited use of shoring

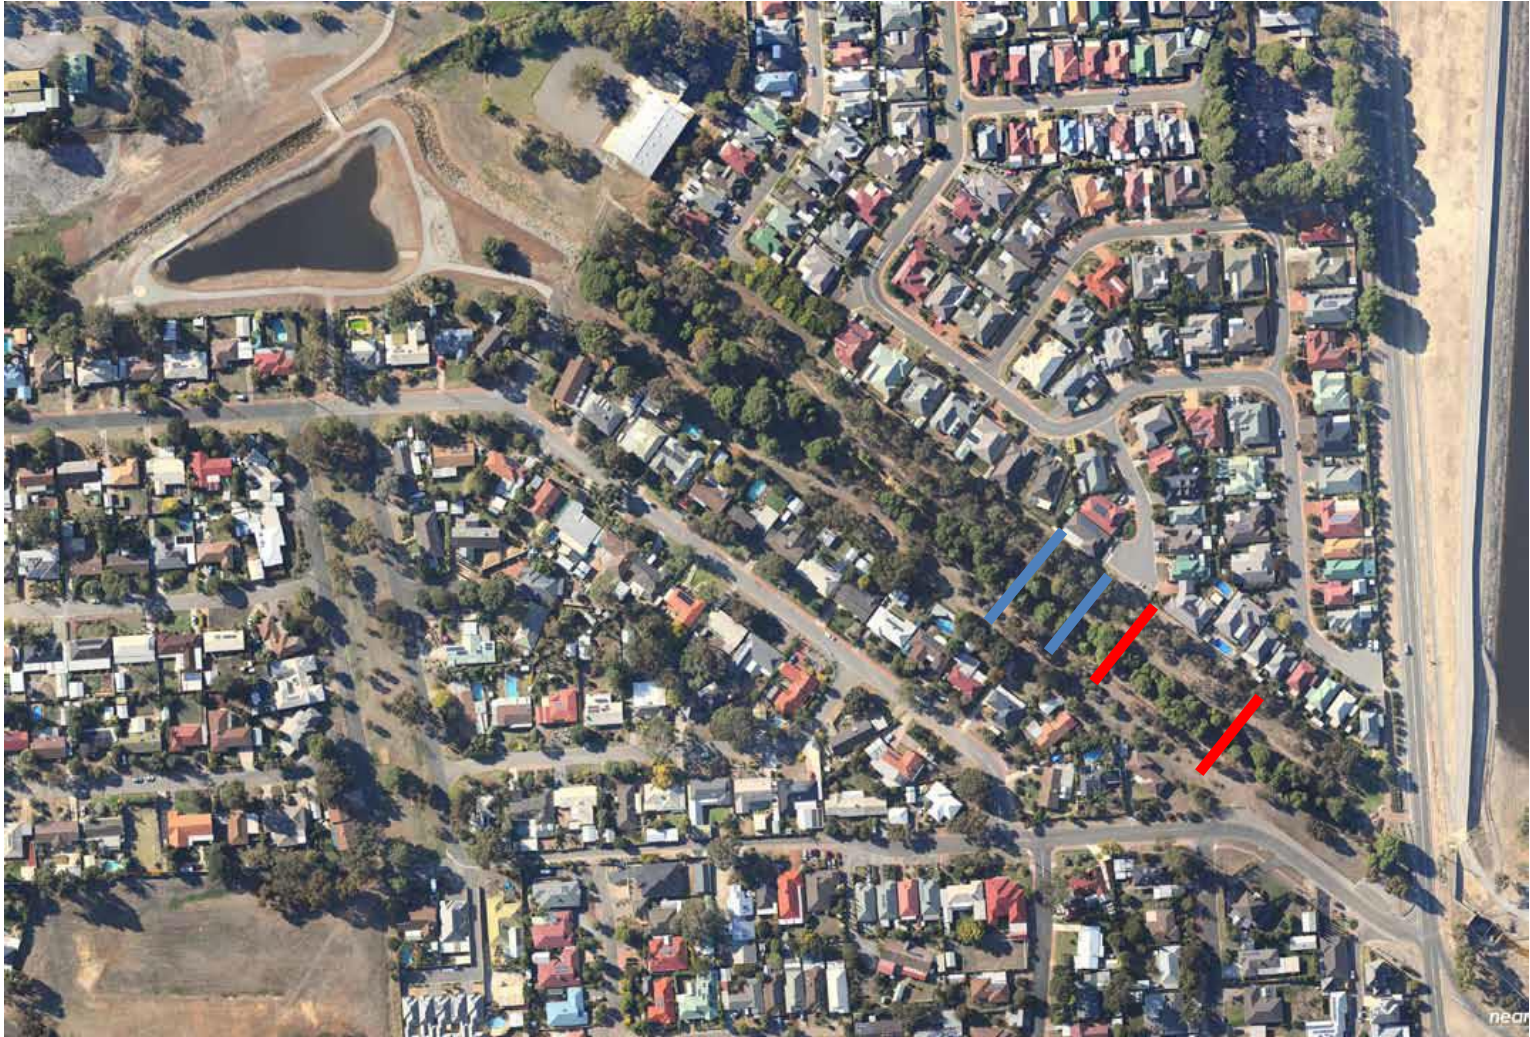
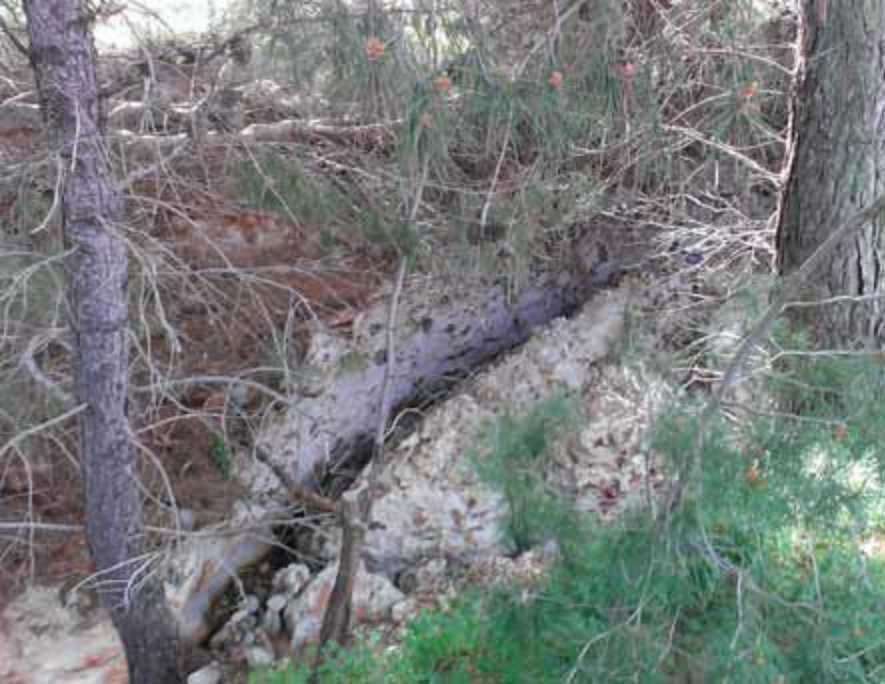
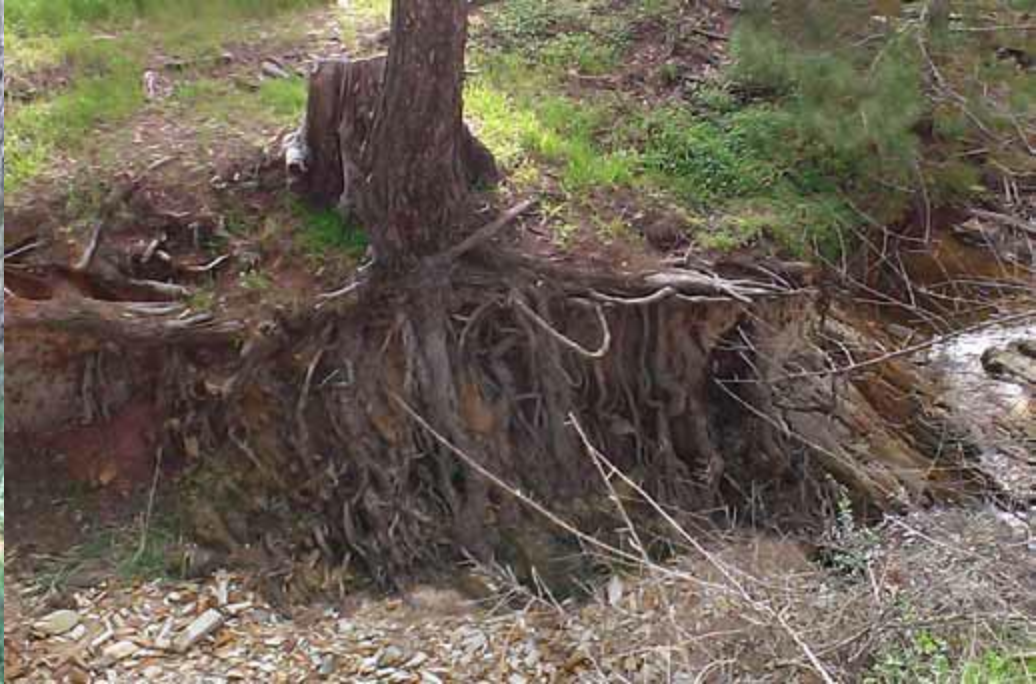
Existing Landscape Character

- Unirrigated grass with scattered native and non-native trees.
- Scattered shrubs with minimal understorey
- Presence of dead vegetation (poorly maintained areas)
- Steeply battered drain alignment with a mixed rock, concrete and gravel base
- Formal trees and understorey adjacent residential subdivision (Tandana Court - Allworth Drive)
- Residential garden extensions into the corridor

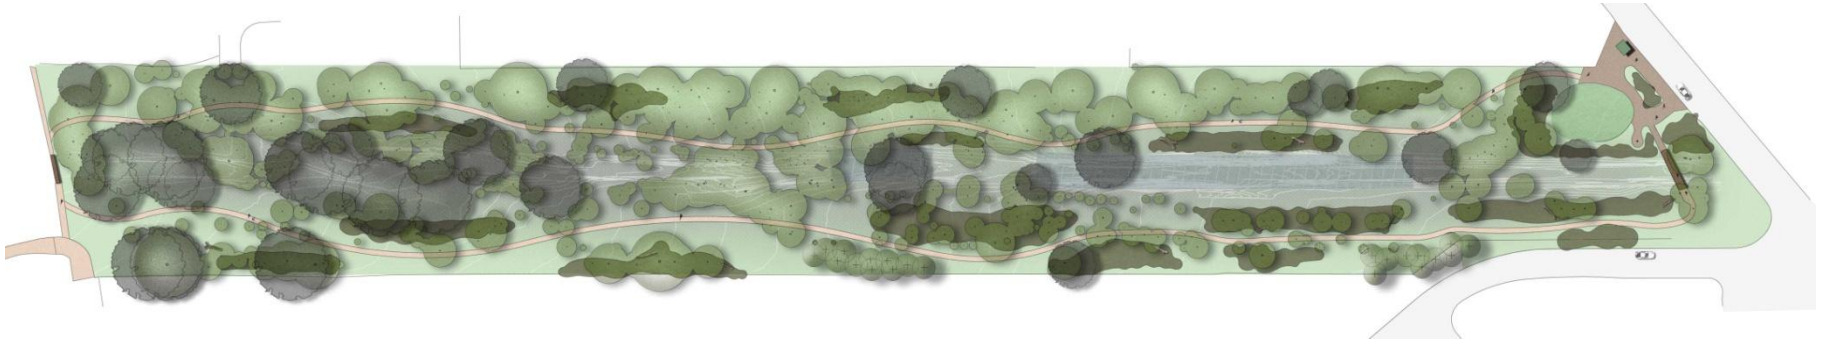
Landscape Plan

- Retain existing trees outside the drain corridor and improve biodiversity with the establishment of native low shrubs and groundcovers
- Retain existing Aleppo Pines outside erosion corridor
- Retain existing Aleppo Pines within erosion corridor where possible
- Replace Aleppo Pines impacted by the drain works with new advanced native trees and select seed producing shrubs (Black Cockatoo)
- Retain open grassland and lift canopies of existing vegetation to improve sightlines (casual surveillance) and ease of ongoing maintenance
- Realign select sections of existing pathways to improve drainage and deter access in hazardous areas
- Retain current access points from adjacent areas

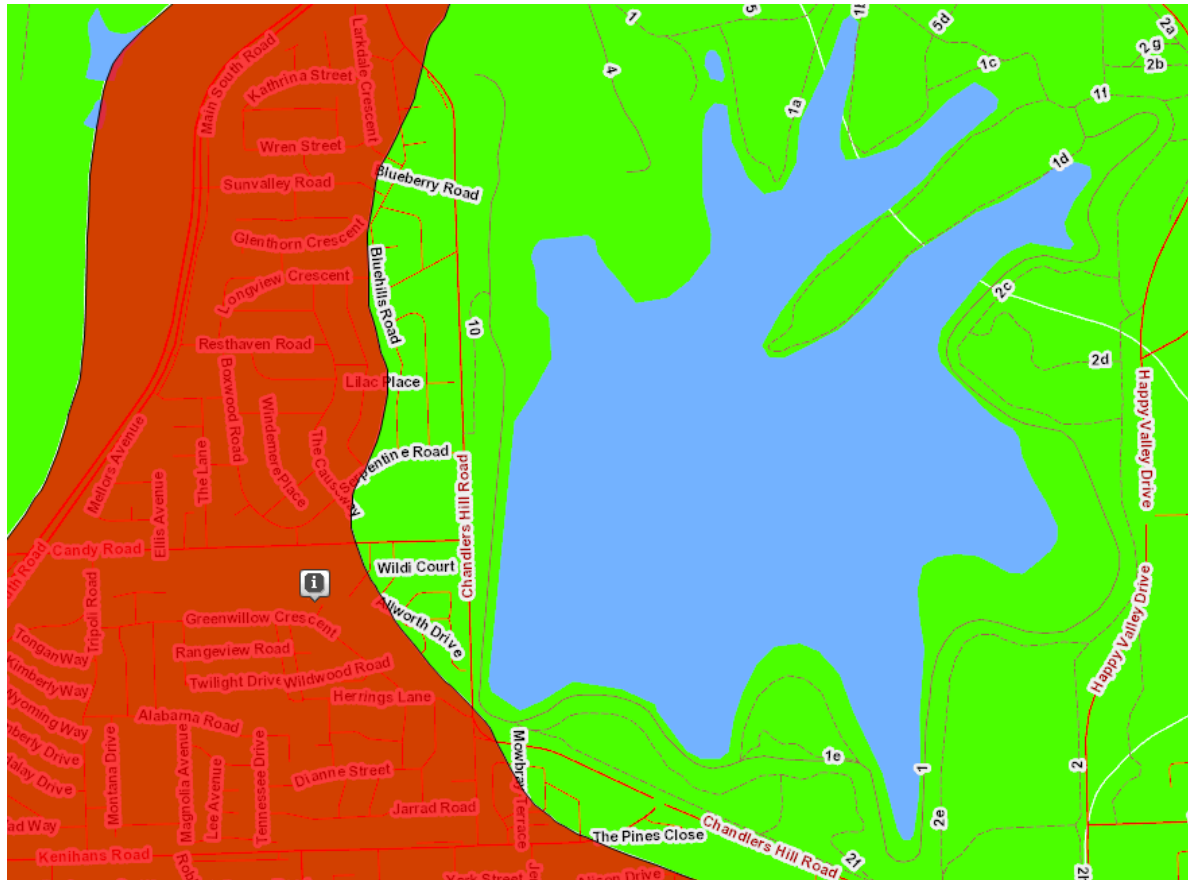
Highlighting (red) historically supported an *Eucalyptus microcarpa* +/- *E. Leucoxyton* Woodland over a grassy and herbaceous understory

- A desktop assessment of the Happy Valley outfall channel was undertaken to determine the vegetation species based on Pre-European Vegetation Mapping of the site (DEWNR).
- Historically, this site supported a *Eucalyptus microcarpa* +/- *E. leucoxylon* ssp. *leucoxylon* Woodland over a grassy and herbaceous understorey
- The site has a distinctive soil type called a Black Cracking Clay (Bay of Biscay Clay). This soil type was strongly associated with Grey Box Woodland Vegetation (*Eucalyptus microcarpa*)
- This Woodland Community is critically endangered under the Environmental Protection Biodiversity Conservation Act (EPBC)
- Project presents an opportunity to re-introduced endangered vegetation back into the area
- Discussions with City of Onkaparinga to explore options of linking our planned revegetation of the outfall channel into the council wetlands
