Inspections

Plumbing Solutions - edition 1

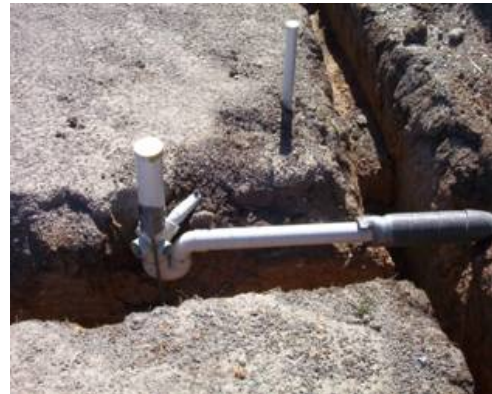
Non-complying underfloor plumbing installation example

The image shows a section of underfloor plumbing installation that is inadequately supported and located in a position whereby it is impracticable to provide a minimum cover of 25mm separation between the discharge pipe and the reinforced concrete slab (refer Clause 3.7.4 AS/NZS 3500.2:2003).

A technical solution to address this issue would be to:

1. Relocate the discharge pipe away from the edge of the footing to achieve both adequate support and separation

or where this option is impracticable

2. Lag the graded discharge pipe between the pipe and the reinforced concrete slab. If the discharge pipe is not on solid ground it will be required to be supported adequately. **NB: engineer approval for option 2 may be necessary.**

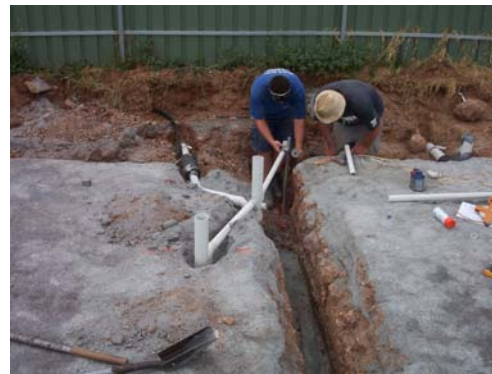
Complying underfloor plumbing installation example

The image shows a section of underfloor plumbing installation where the discharge pipe is offset from the edge of the footing whereby the pipework is fully supported on the pad.
